## Issue No. 9/2013:

### Lack of performance or whistling noises after a turbocharger replacement? The truth is in the gasket.

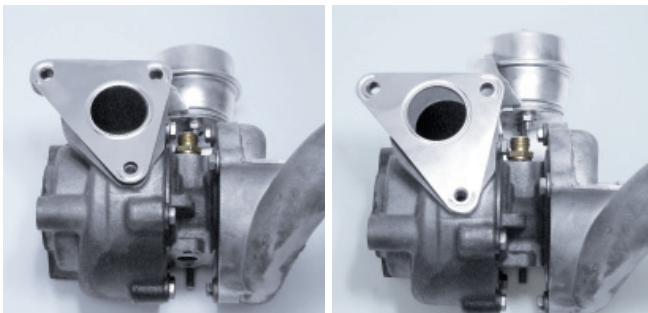
In many applications the exhaust manifold gasket can accidentally be installed incorrectly. Because the gasket no longer correctly seals the outlet of the manifold, leaks occur—and thus the noises described above. The exhaust flow rate can also be reduced as the opening is smaller, which prevents the turbocharger from providing full power. This does not necessarily coincide with the whistling noise mentioned previously.

Figure 1: Example for 021TC15195000: The gasket left is installed correctly; the right one is the wrong

THEREFORE, OUR ADVICE IS: MAKE SURE THE GASKET IS FITTED CORRECTLY EVERY TIME THE TURBOCHARGER IS REPLACED.

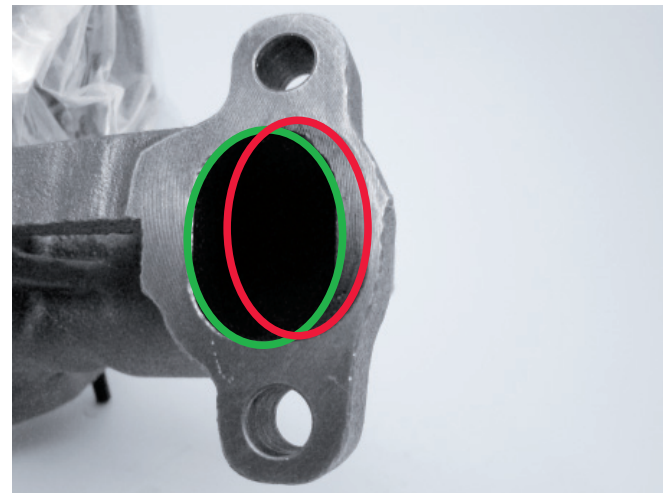
Figure 2: Example for 030TC15116000:  
Red oval: incorrect position; green oval: correct position
