## Issue No.: 5/2012 – Filter inserts KX 178 D, KX 228 D, and KX 220 D (VW/Audi applications): risk of leaks due to assembly error

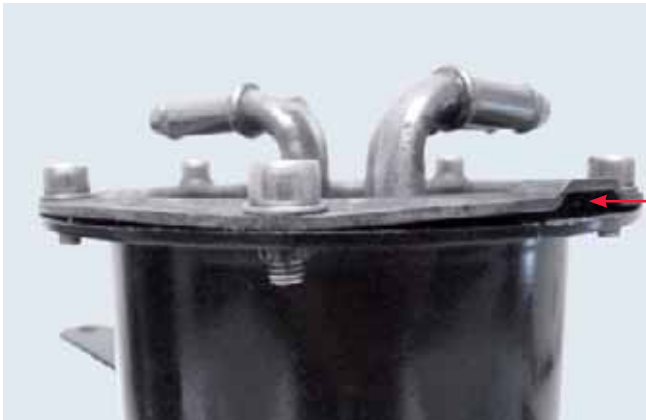
However, the examination of the housing parts indicated a deformation of the housing cover, caused by incorrect opening and/or closing of the filter housing.

Point for correctly levering off the cover

Figure 1: This housing cover (KX 178) was deformed by being opened and/or closed incorrectly.

Our advice: it is essential to ensure that no damage to the housing cover occurs when the filter element is professionally replaced.

- An unsuitable tool is used to remove the cover (VW recommends the use of the special tool VW number VAS6543).
- The cover is not levered off at the designated point (see photo); the same applies to the housing cover's gasket ring.
- The new gasket ring for the housing cover is not adequately wetted with fuel.
- The cover is only closed against the housing by tightening the bolts (the cover should be pushed on to the housing by hand and only then tightened with the bolts to create a perfect seal).
