## Issue No. 6/2013: Not fully sealed? Installing coolant thermostats correctly

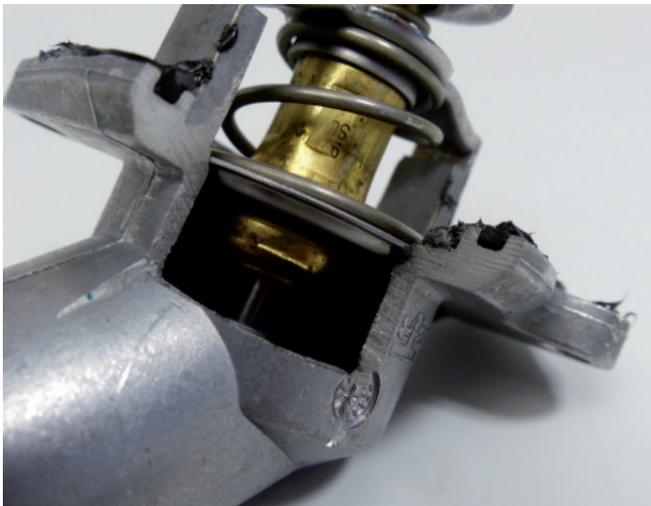
Time and again, thermostats are returned to MAHLE under complaint because they apparently leak or do not work correctly. Incorrect application could be one reason of this. However, the cause is frequently the use of sealant or instant gasket during installation, which can result in several problems.

oil-resistant. If sealants containing mineral or synthetic oil particles are used, this leads to a swelling of the gasket—and thus to its decomposition.

The gasket design has been calculated to exactly fill the gasket groove. If a sealant is applied during installation, a complete seal can no longer be guaranteed due to the additional volume.

Frequently sealant is applied so liberally that paste particles end up in the coolant circuit. This has serious consequences: the sealant particles can swell up and obstruct the coolant flow. They can deposit in the thermostat, so that it can no longer open or close properly, which may lead to system overheating.

*The application of sealant has led to the thermostat no longer sealing properly.*

On the basis of the risks depicted, MAHLE strongly recommends to not use sealants or instant gaskets and will reject any claims caused by their use.
